# Manhole Inspection Summary

Manhole # S29II1028MH

Insp Date: **4/17/07 8:47 AM**

**Location** Address: **4004 MEADOW LA**

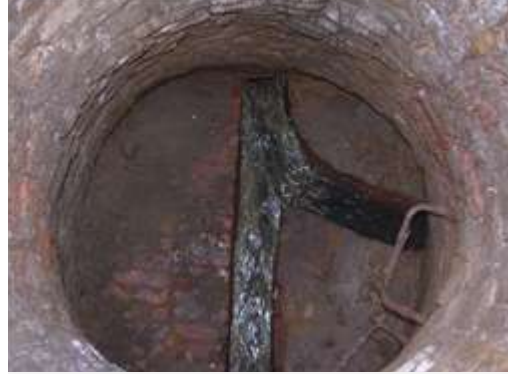
Top View

Corroded steps. Evidence of surcharge - Bench debris. Channel debris.

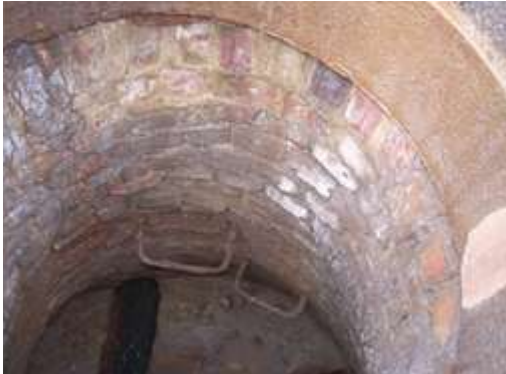
Defect

Frame leaks. Adjustment and Corbel deterioration and infiltration. Barrel infiltration.

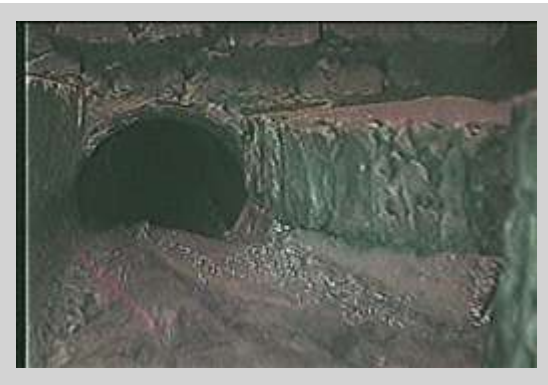
Pipe Out @ 12 O'Clock

Barrel deterioration and infiltration. Channel deterioration.

Infiltration: **Evidence** Pipe Seal Cond: **Cracked**

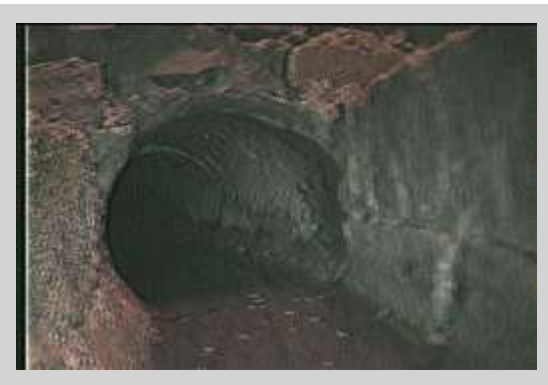
Pipe In @ 3 O'Clock

Deposits: ☐ None ☒ **Mud** ☐ Sludge ☒ **Debris** ☐ Grease

Silt Depth: **0.5** (in.) Deposits Extent: **Light**

Infiltration: **Evidence** Pipe Seal Cond: **Cracked**

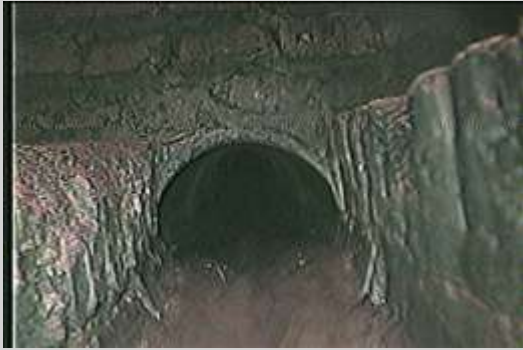
Pipe In @ 6 O'Clock

Barrel deterioration and infiltration. Channel deterioration.

Infiltration: **Evidence** Pipe Seal Cond: **Cracked**
